Appendix C
Laboratory Testing

GLA JOB NO. : 2005-033
 CLIENT: KFM # TRG 07-02E
 JOB NAME: Site D, Diamond Bar

Appendix D
Slope Stability Analyses

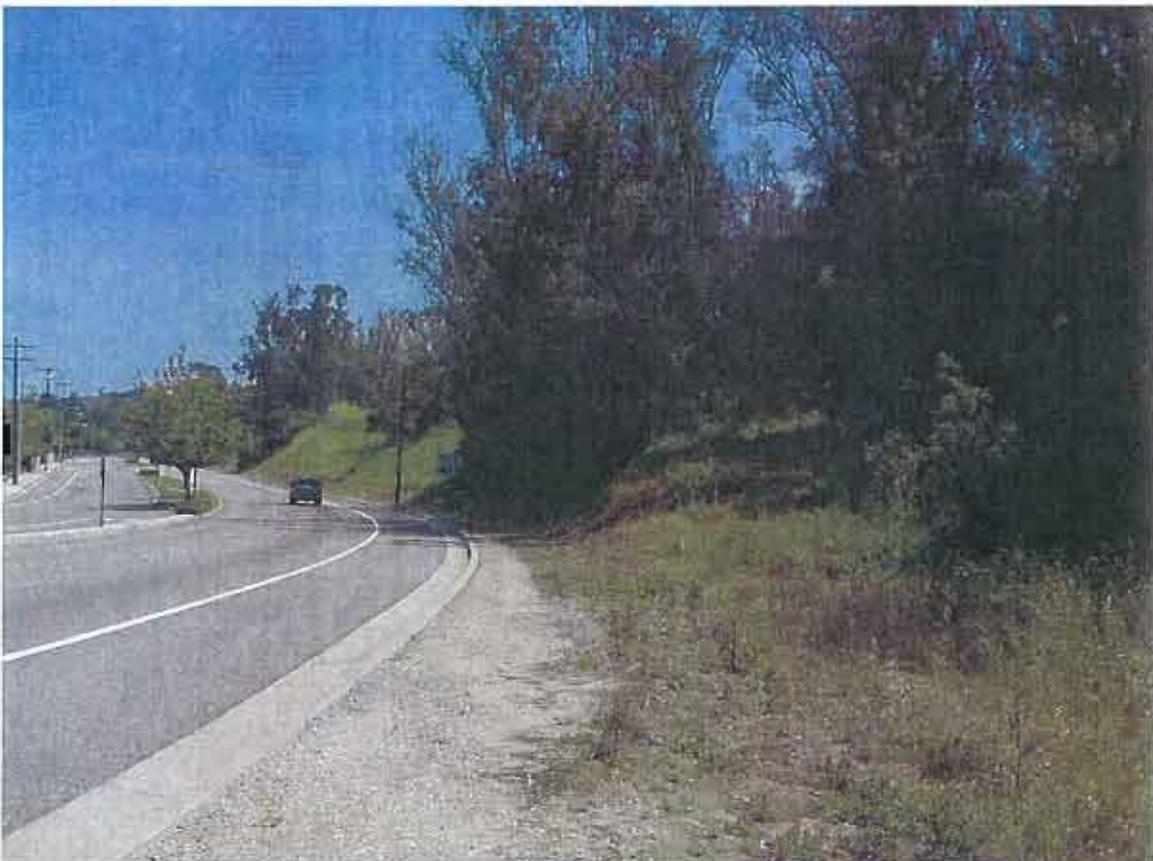
PHOTO 2 - VIEW FACING EAST FROM THE NORTHWEST CORNER OF THE SITE. DIAMOND BAR BOULEVARD IS EVIDENT. THE SMALL UTILITY POLE IN THE BACKGROUND ALONG THE NORTH SITE BOUNDARY IS SUPPORTING TENSION CABLES.
